Memorandum

Re: Recommended field sites for SmartWood assessment team

This memo outlines the Ecology Action Centre's suggestions for field visits during the SEPH assessment. All page and grid locations refer to the 2001 Nova Scotia Map Atlas, unless otherwise noted.

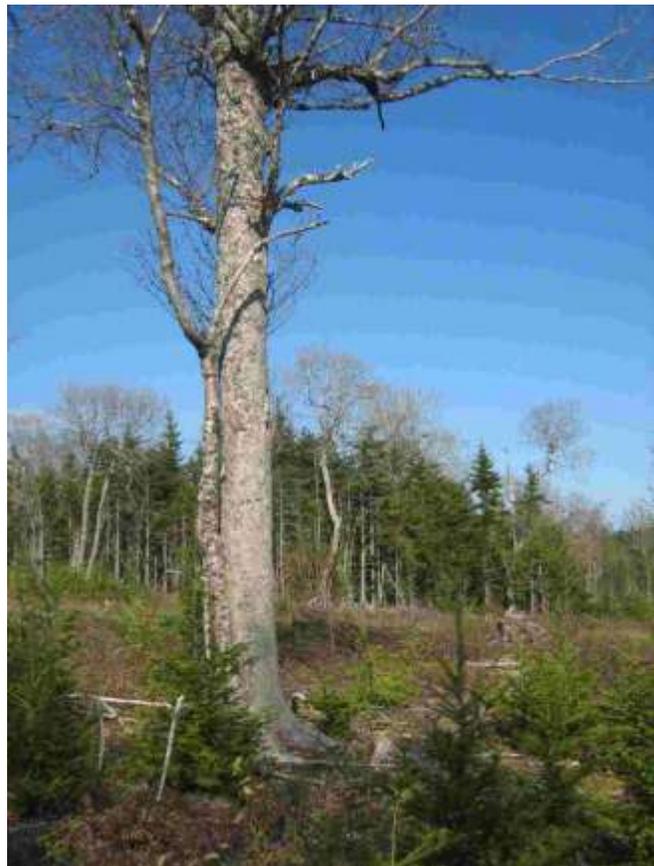
This site was planted to black spruce several years ago, and was being out-competed largely by yellow birch, as well as red maple and white birch. Contractors were told to remove competing hardwoods, which included cutting many young yellow birch stems. Remnant mature yellow birch and sugar maple trees were present, as well as a few white pine.

SITE 1: Yellow birch in midst of clearcut & Black spruce plantation

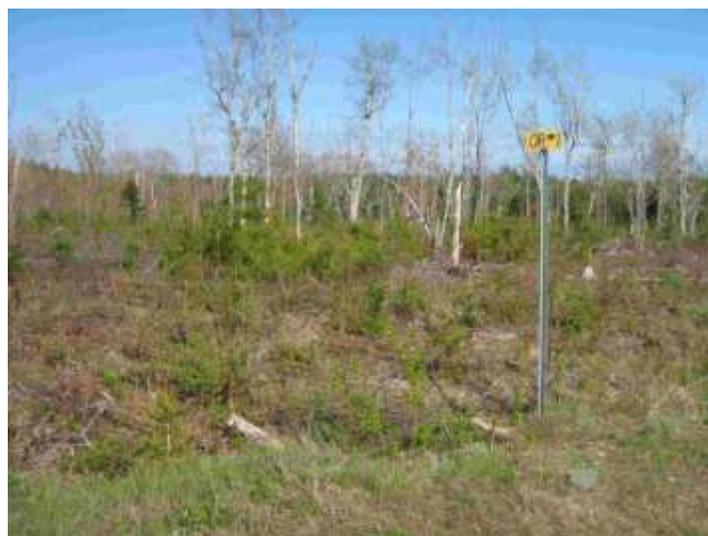
Site 1: Competition cleared around softwoods

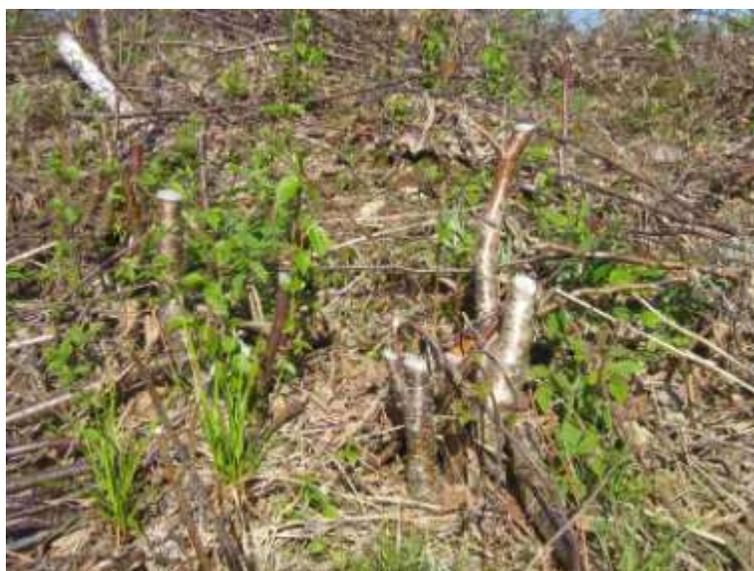
Site 1: Recently weeded young yellow birch saplings

Planting this site to Black spruce, and removing much of the vigorous yellow birch regeneration conflicts with the purpose and intent of the Maritime FSC standards, and in particular, standard 6.3.

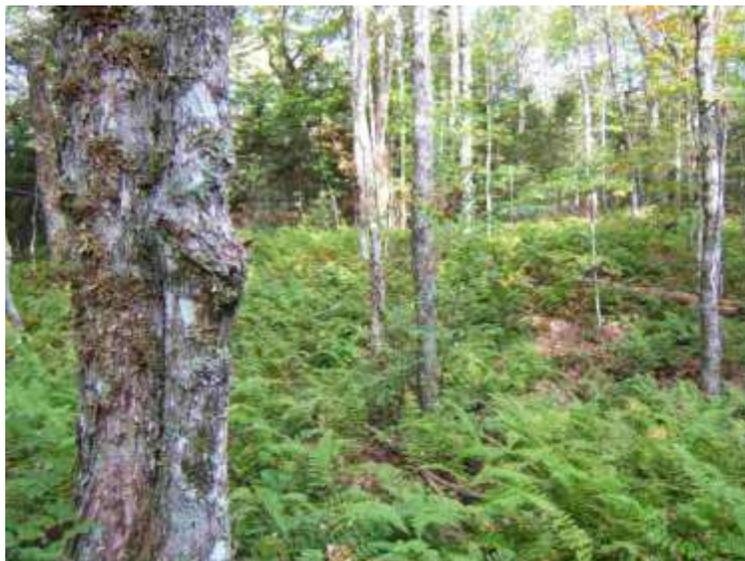
Site 2: Young sugar maple stand

- this is one of the few stands left in the area that had some semblance to its natural, site-evolved species;
- there are few older stands left in the entire County;
- the site has considerable potential for uneven-aged management and maintenance as a tolerant mixedwood stand;
- many of the sugar maple are young;
- it is unclear what a group selection would do to improve quality or maintain sugar maple on the site;
- the proposed prescriptions could significantly alter the structure and composition of this stand, reducing the tolerant softwood and hardwood component, and compromising future quality; and,
- SEPH could use this opportunity to learn and experiment with restoration.

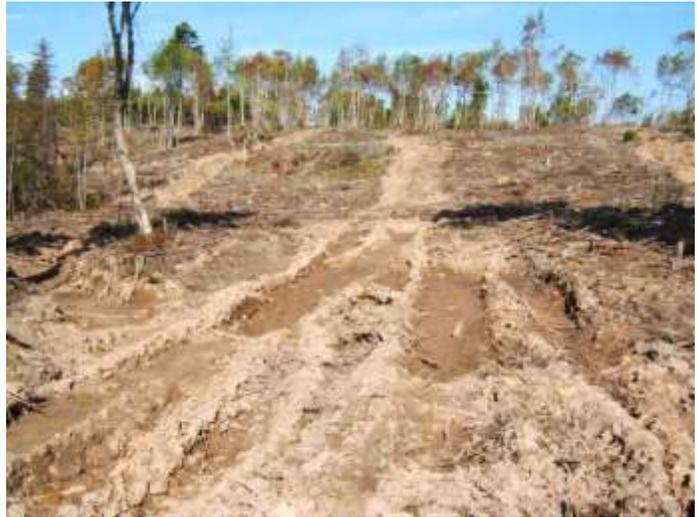
This recently harvested site was comprised of balsam fir, spruce and intolerant hardwoods. Logging had continued throughout very rainy weather in June, resulting in considerable rutting throughout the harvest block and on the main trail leading to the block, which was located in a poorly drained, low-lying area.

- Climate patterns appear to have shifted such that wet weather near the coast in June and July has become fairly common.
- The soil damage to this site appeared to be extensive, but Stora's concerns were mainly directed toward potential damage to the nearby stream, and not to onsite productivity.
- The initial location of the access trail in a wet, low-lying area demonstrated poor planning.

Site 3: Skid trails and ruts in clearcut

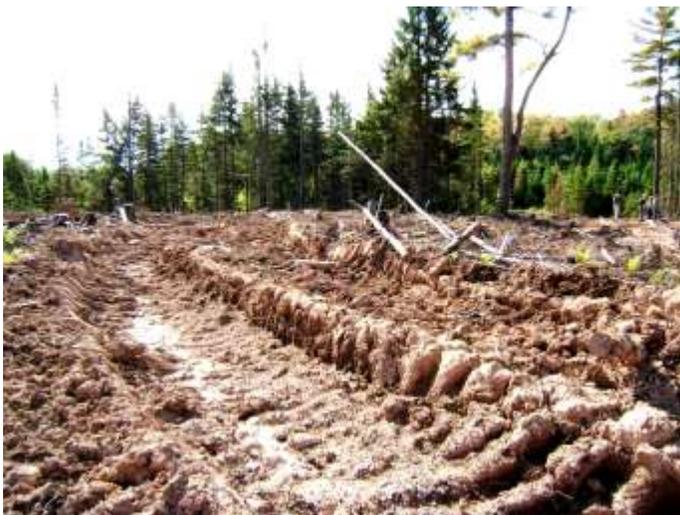
Site 3: Ruts in clearcut

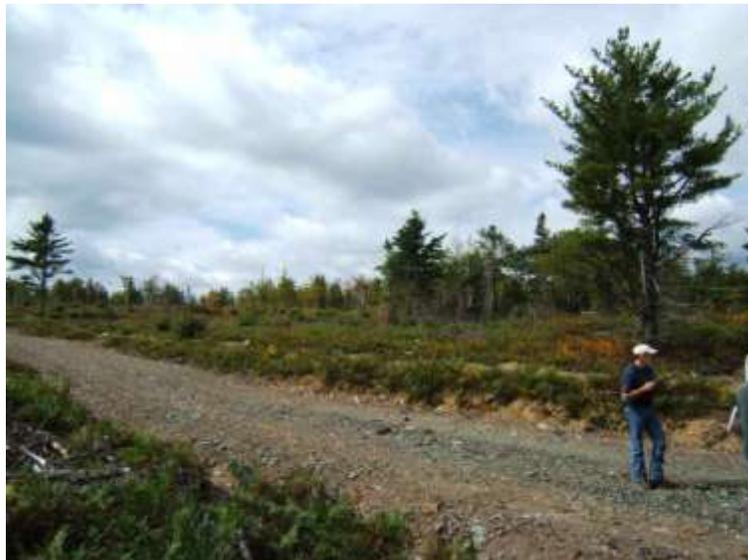
The remnant pine have weevil damage, which would suggest that any new pine regeneration, growing in open conditions, will also incur weevil damage.

We are concerned that SEPH's preference for spruce pulp and lumber is leading to the marginalization of merchantable pine from this site. The open conditions will continue to result in weeviled white pine, which would suggest the managers are not managing for optimal value.

Site 4: White pine with weevil-damaged trunks in clearcut

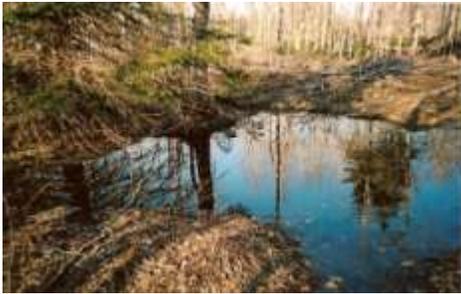
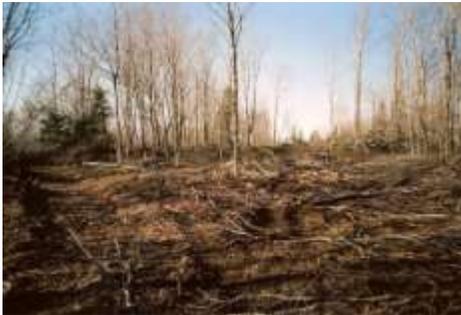
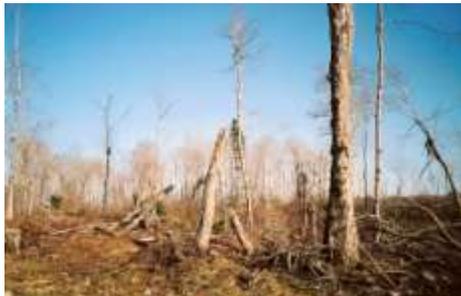
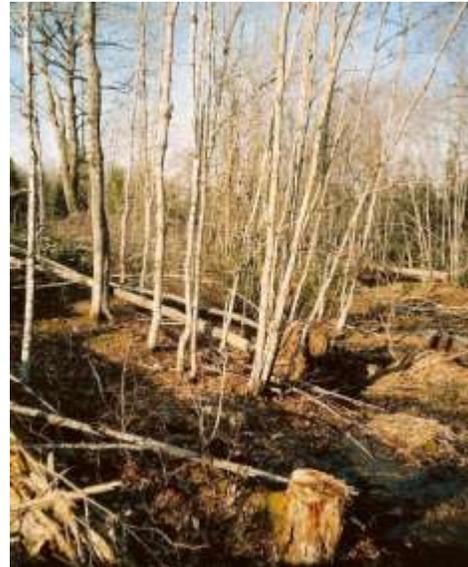
We are concerned that the treatment has altered the ecological characteristics of this forest. The following set of photographs demonstrates cutting up to vernal pools, inadequate maintenance of cavity and large-dimension trees, fragmentation and edge effects.

Hardwood quality had also been compromised. Canopy openings were large and residual

Site 5: Cutting in tolerant hardwood stand, Weaver’s Mountain

stocking levels low, risking increased incidence of stump sprouts, epicormic branching, sunscald, top decline, stem forks, invasion of undesirables and shorter clear bole length.

There was no targeted removal of poorly formed and diseased trees, and there was no apparent plan in place to move towards residual stocking levels by size class for the maximization of sawlog production.
